Polychrome majolica of Apulian domes: history, technique, pathology and conservation

Mariella De Fino¹, Vito Domenico Porcari², Albina Sciotti¹, Antonella Guida², and Fabio Fatiguso¹

Abstract: The paper is focused on the historical-architectural evolution and material-technical qualification of polychrome majolica domes that were built between the 17th and 19th centuries in Apulian religious buildings. In particular, the cultural context in which this solution spread throughout the Mediterranean area is identified. Moreover, the case history of construction and decorative techniques that are distinctive of the regional territory is discussed in terms of underlying structure, installation of elements and surface colours. The study is then detailed on the Church of Santa Maria della Vetrana in Castellana Grotte (BA), for which the morpho-typological survey and mapping of the decay state are presented, based on the use of terrestrial and aerial digital photogrammetry. Finally, based on the identification of the main pathologies from both direct and indirect alteration factors, the most appropriate conservation and maintenance interventions are outlined, with specific focus on repair

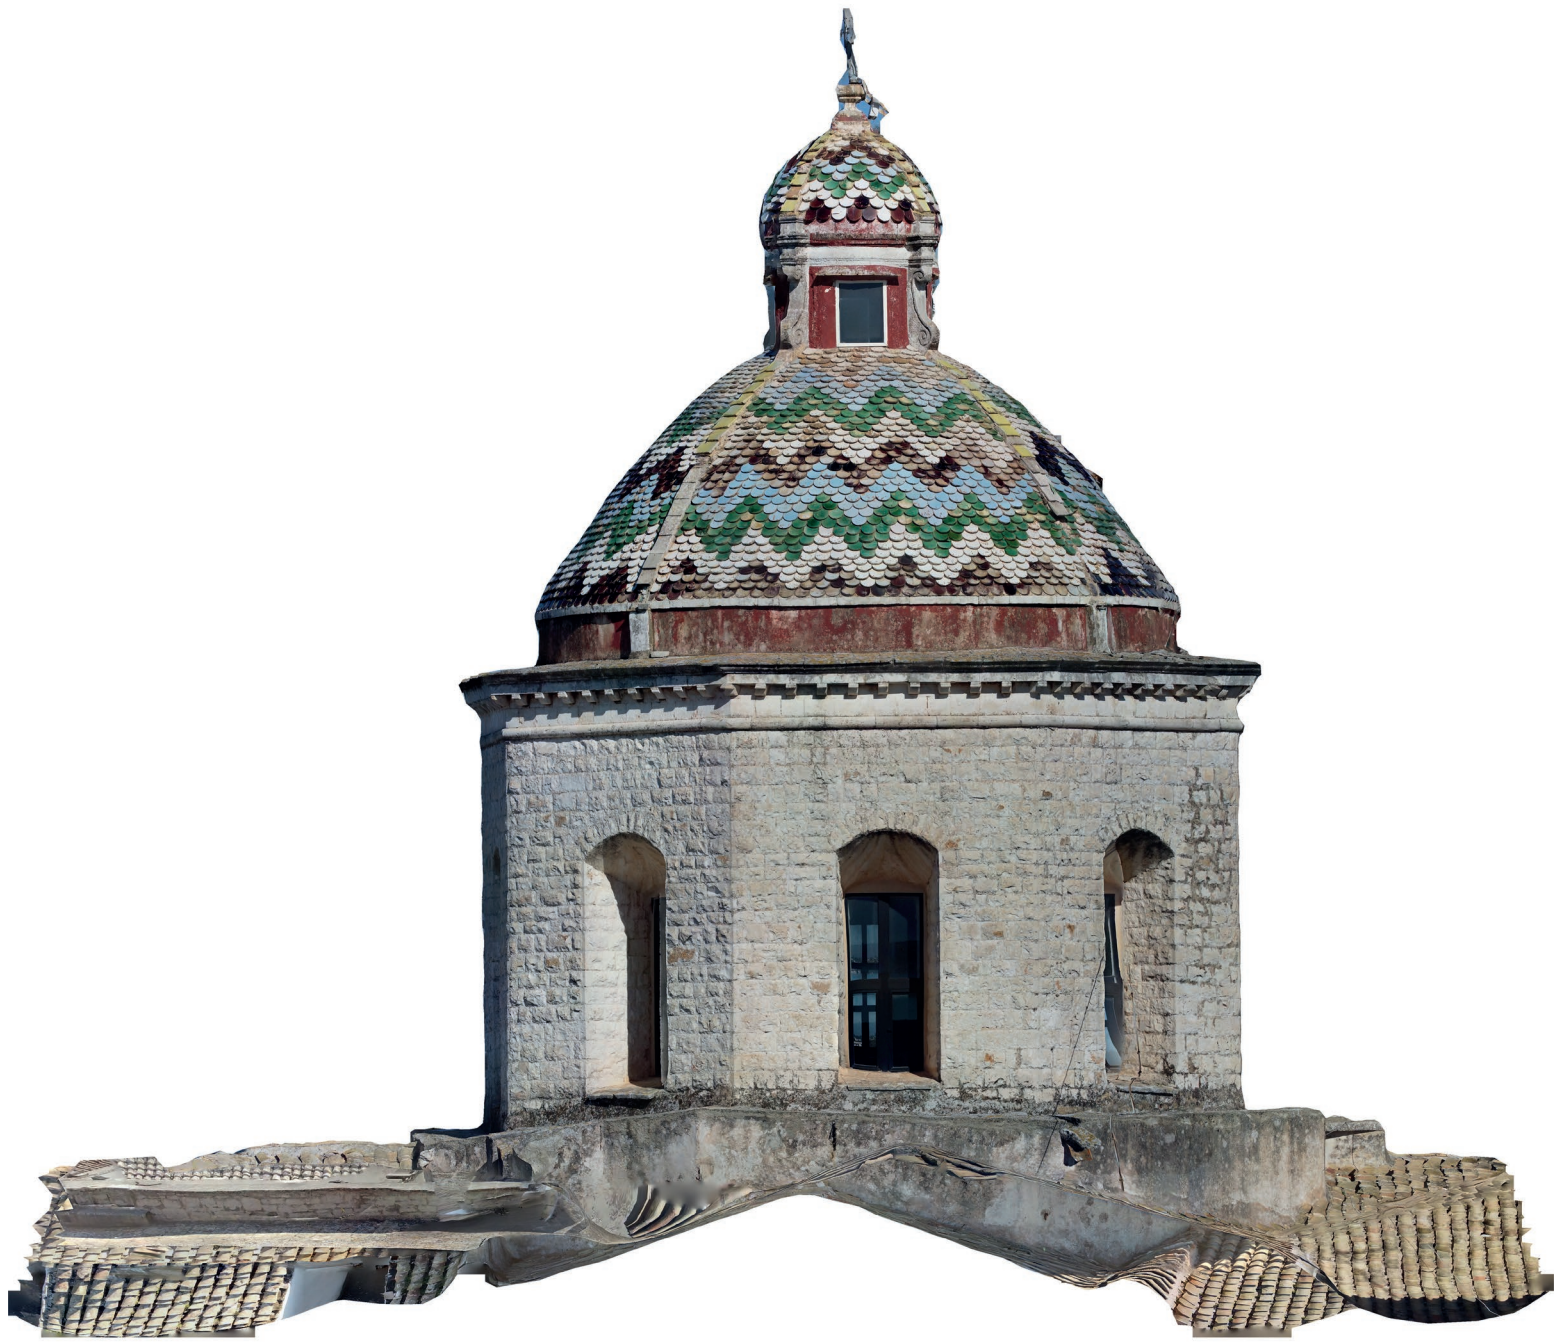
3D model of Apulian polychrome majolica dome.

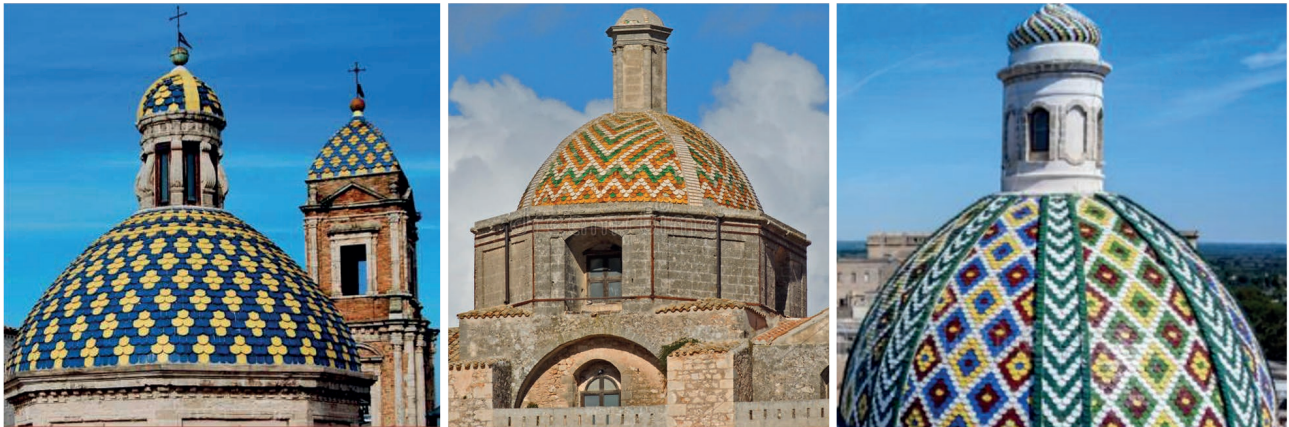
Figure 1 | Examples of Apulian majolica domes: (from top) Domes of Conversano, Oria and Ostuni.

Particularly, the research herein focuses on a peculiar geographical context such as the Apulia Region (Fig.1), where the construction and architectural practice, as well as the wise use of building materials, has resulted in living identity testimonies of a past time that must be transmitted to the future. Although there is no certain historical evidence, some scholars have speculated that the Apulian majolica domes represent memories

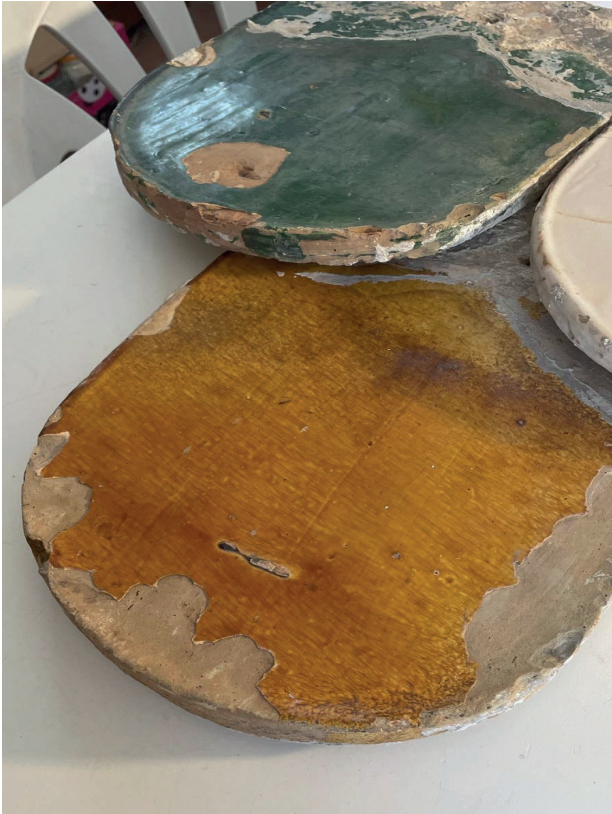
Figure 2 | Examples of Apulian majolica tiles. *Source:* Courtesy of Bottega Vestita srl, Grottaglie.

There are also different methods of production, transformation and installation of these elements. In fact, beyond the most common rectangular glazed bricks, the dome mantle is often made out of shingles, namely roof tiles with an elongated shape along the vertical axis, ending in the lower part with a semi-circumference. In this solution, the ceramic might vary by size and geometry, having a width between about 17 and 20 cm, a length between about 25 and 30 cm and a thickness of about 2 cm to give greater mechanical resistance (Zerlenga, 2021; Dell’Aquila, 1979). In the traditional technique, the element has a small hole at about 4 cm from the upper part that houses the anchoring to the dome extrados through nails (Fig. 2).

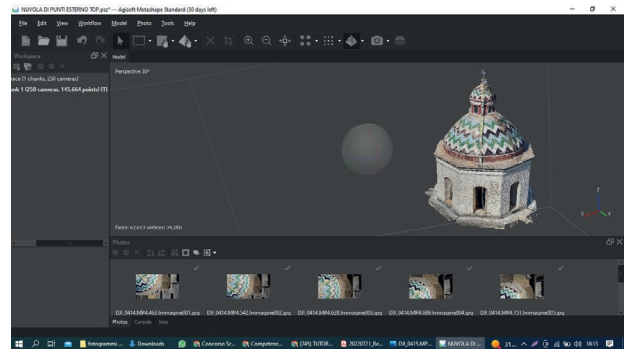
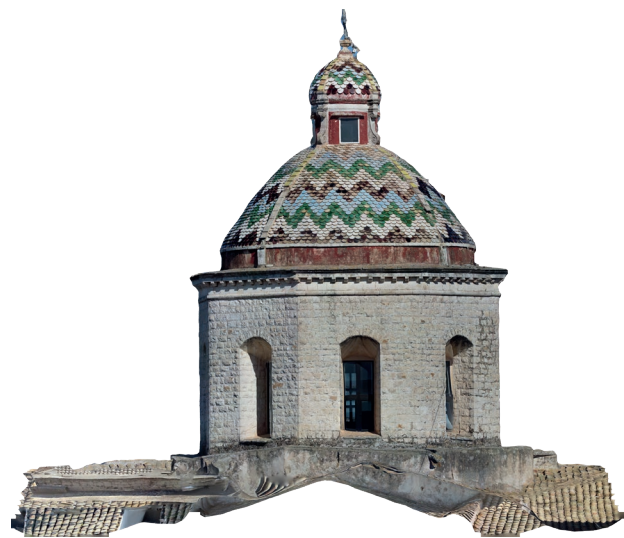
Figure 3 | Dense coloured point cloud.

Both sets of images were processed by Agisoft Metashape® software, elaborating dense point clouds and textured polygonal meshes (Fig. 3), suitably scaled with the aid of control targets that were installed onsite before the acquisition.

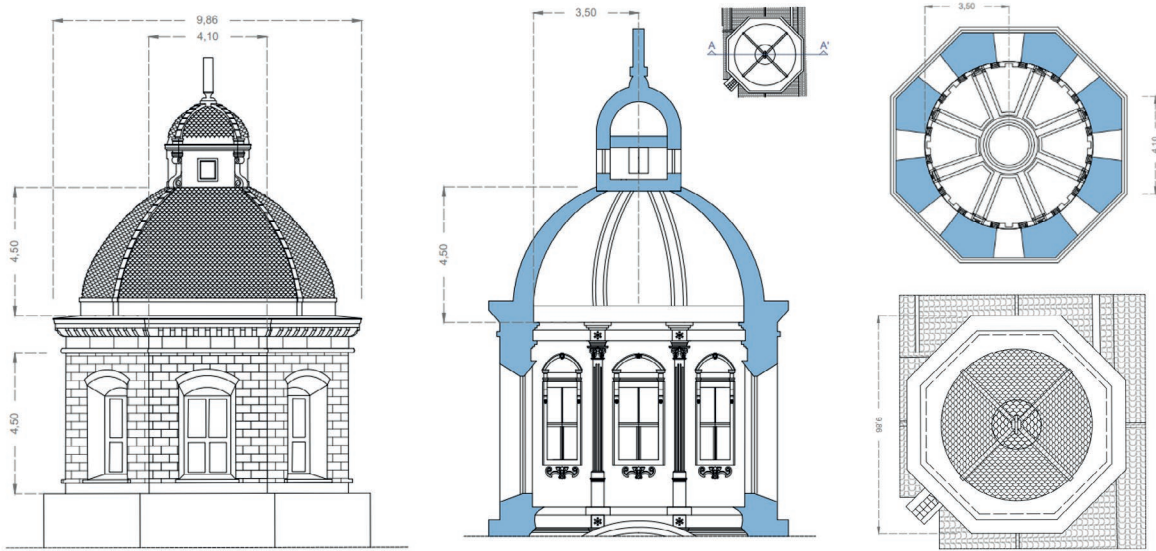
Figure 4 | Geometrical drawings.

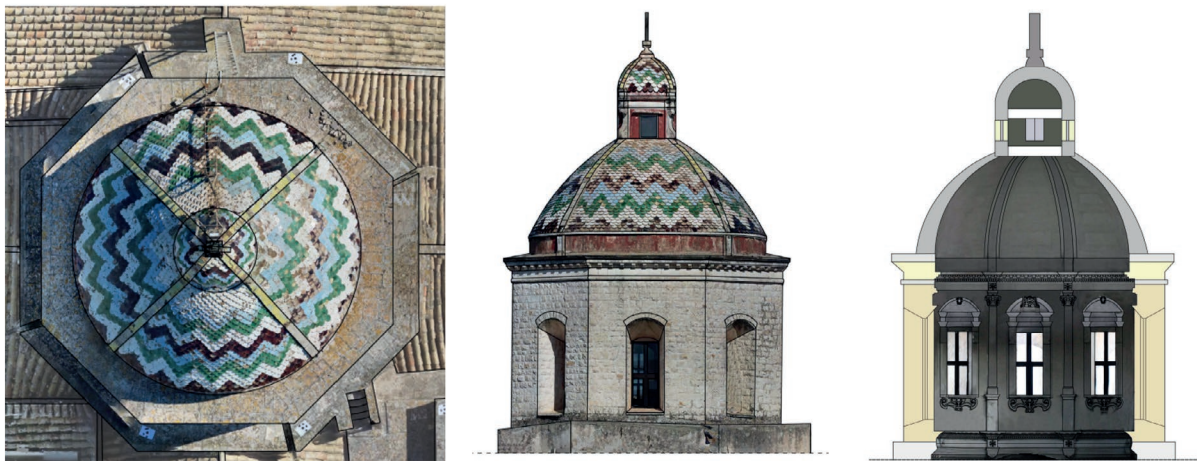
Figure 5 | Orthoimages.

The orthoimages, extracted from the photorealistic three-dimensional model, were used as a support for the accurate decay mapping of all the internal and external surfaces of the dome and of the underlying elements / spaces (Fig. 6).

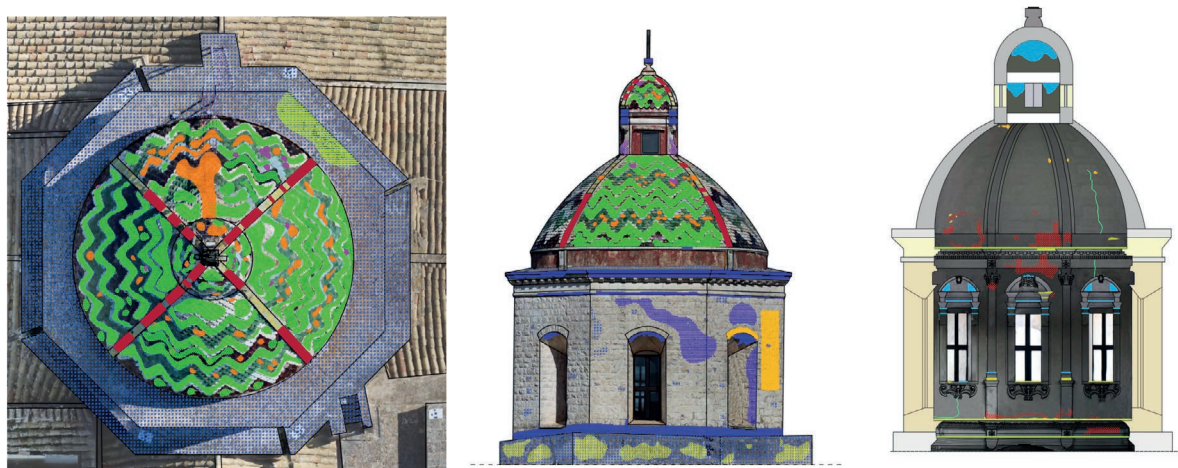
Figure 6 | Decay mapping, including internal cracks (green lines) and humidity patterns (light blue areas) and external missing elements (red), fracture of elements (purple), chromatic alteration (orange) and detachment of coating (light green).

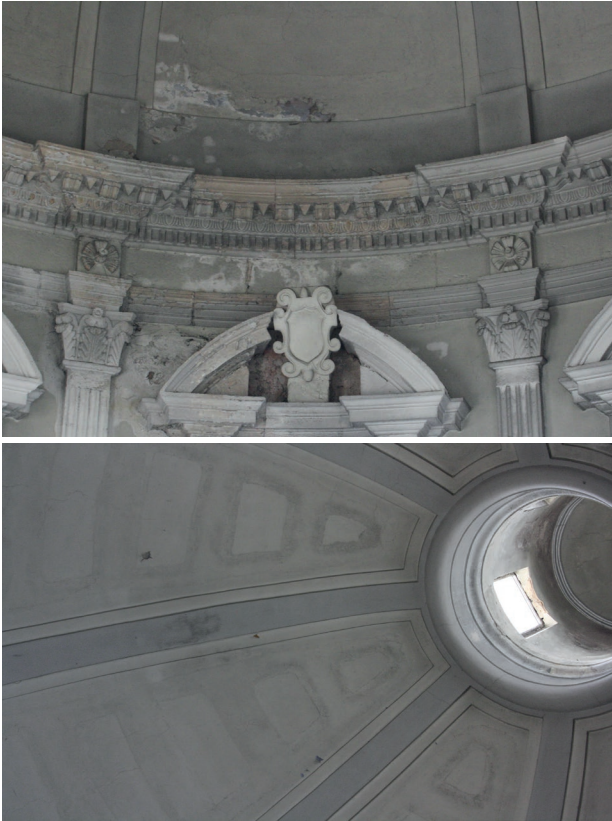
Figure 7 | Humidity patterns of the intrados, including infiltration efflorescence at the dome/drum connection (top) and condensation on the internal surfaces of the lantern (bottom).

In particular, from the overall analysis of the mapping results and in line with the workflow presented in §2, three macro-categories of alterations were found. Among them, the decay patterns that are most relevant for the purposes of the present study are: (i) Crack patterns of the dome intrados along the meridians of the cap; (ii) Humidity patterns on the dome intrados and on the internal wall surfaces, both localized and diffuse: localized, with efflorescence at the connection between the dome and the drum across the decorative elements, such as pilasters, cornices and coats of arms; diffuse, with chromatic alteration of the plaster, on the internal surfaces of the lantern (Fig. 7); (iii) Physical deterioration

Furthermore, the spatial distribution and deterioration effects of the humidity patterns resulted in the identification of two different, albeit concomitant, phenomena: infiltration humidity from rainwater, which passes through the masonry structures, in particular in

the connection points (e.g. dome-drum), is enriched with salts that crystallize on the internal surfaces during the evaporative processes and, thus, shows efflorescence stains; and condensation humidity, in particular in the lantern, where the top position of the element, the thermal inertia of the walls and the absence of ventilation through the openings, which are constantly closed, cause the transition to the liquid state of the indoor air vapour, especially in summer.

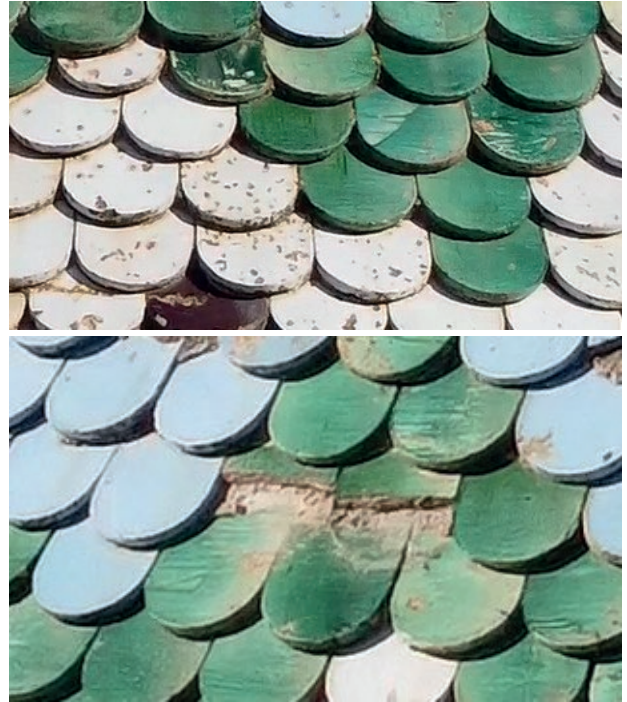
Figure 8 | Decay patterns of majolica shingles, including fracture, detachment of the vitreous coating and chromatic alteration.

patterns of the majolica shingles, in the form of missing elements, fracture of the elements - with regular or irregular breaking line - detachment of the vitreous coating, chromatic alteration and leaching (Fig. 8).

In detail, it is noted that the shingles are affected by pathologies due to exposure to external atmospheric agents, which have compromised the physical integrity of the coating / element, eventually where manufacturing and installation defects occurred as well.

With specific reference to repair/integration of shingles with fractures and missing parts, the most appropriate approach depends on the regularity of the breaking line. If regular, it is feasible to integrate the shingles with new ones, similar in size and pigmentation, suitably serrated and chamfered with manual tools to match with the portion of majolica in place. If irregular, it is necessary to make a preliminary clay cast of the breaking line, for the offsite manufacturing of the complement to be integrated onsite. In both cases, it is, then, essential to proceed with the joining of the two fractions, to be carried out by fixing the new portion to the supporting structure with high-performance, deformable, fast-setting and hydrating cementitious adhesive and subsequent coupling of the two portions with sealant and single-component thixotropic polyurethane adhesive.

Otherwise, in case of detachment of the vitreous coating, it is advisable to proceed with micro-injections of silane-based solutions, suitably added with micronized silica, to avoid the effect of yellowing from exposure to ultraviolet radiation. Finally, in the presence of chromatic alteration and leaching, even on elements affected by the aforementioned alterations, it is emphasized that the
