## METHODOLOGY FOR THE CHARACTERIZATION OF BUILDING ENVELOPE: VIRGEN DEL CARMEN GROUP AT VALENCIA

This communication is developed within the activities of the project funded by the Valencian Regional Government "The heritage consideration of the social Modern Movement's public housing. The Virgen del Carmen group, revitalization, and energetic updating (MOMOVISO). In this project, a Modern Movement heritage social housing research is proposed to progress in the preservation of this architecture. Accordingly, a methodological model is made and applied to Valencia's 614 housing estate, placed in the suburb zone named "El Cabañal". This residential complex was designed by the architects Fernando M. García-Ordóñez and Juan M. Dexeus Beatty, and it was built between 1958 and 1962. It was developed under the new social housing regulatory framework, which considers different configurations, as well as new constructive techniques, aimed at standardizing the quality of their systems and components and improving the dwelling's indoor comfort. The present communication is a summary of the analysis process leading to ideation of a comprehensive methodology for the buildings envelope character

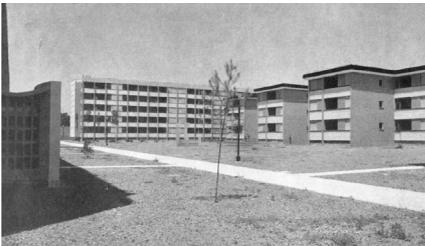
Figure 2. Construction works finish image. Source: (CSIC 1963)

The organizational structure used in the group design is unrelated to the near housing environment. Large urban open spaces and open edifications were built. For buildings, two types were designed: linear buildings of 4-5 floors, with a reinforced concrete outdoor seen structure, and two dwellings per stair landing. Furthermore, 2-5 floors towers, with bricks bearing walls, and three dwellings per stair landing (Fig. 1). Thus, housings had cross ventilation and an adequate geographical orientation to guarantee certain passive measures to generate indoor comfort (Jordá-Such 2009). Dwellings have a minimum extension, for 2, 3, or 4 bedrooms. A strong Central European functionalism connection is evidenced within its design, it is expressed in the use of both urbanistic and architectural criteria (Palomares-Figueroa and Jordá-Such 2010). Independence between vehicles and pedestrian flow, construction of green and living areas between parallel buildings, façades shaped by large openings or terraces modulation, standardization and prefabrication of constructive systems and installations, flat roofs, and not ornamental finishes (Fig. 2).

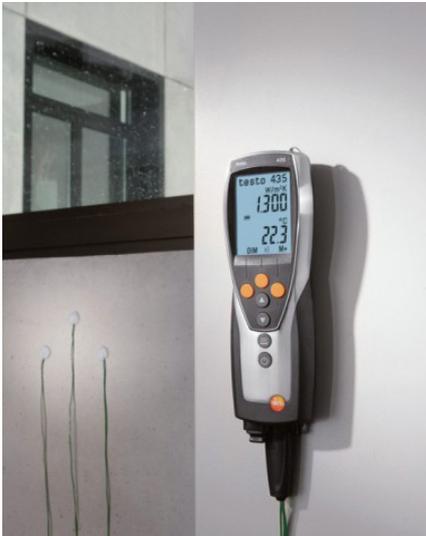
Figure 7. Thermal transmittance measure device, model Testo 435

- Theoretical approach with eCondensa2 software (Fig 8).
- In-situ testing with a portable device, model Testo 435 (Fig. 7). This test provides an indirect measure of the envelope transmittance values. For this purpose, a wireless external temperature probe takes the outdoor temperature values. While another internal probe with four sensors is collecting data, three of them are collecting the wall temperature data, and the last one catches the indoor temperature. All

of this is to obtain the wall temperature transmittance.

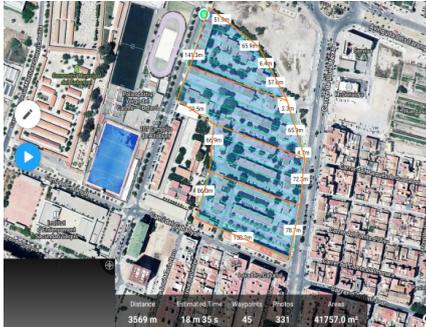
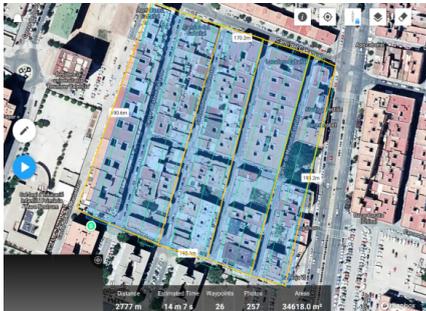
Figure 9. The two study areas for the aero-thermographic survey. Source: [www.google.es/maps](http://www.google.es/maps)

Two study areas are analysed, as comparisons between two different urban typologies and their effects on the public spaces of thermal flows can be made. Each area is subdivided into several smaller sectors, so they are easier to be analysed during the flights (Fig.9). The late afternoon is the best time for the data collecting, as it is possible to obtain them after the whole day of sun radiation, avoiding the direct sunny radiation distortions.

The time flight in every area is 30 minutes approximately. The used drone is a DJI Matrice 210 (S/N: 0G0DE7R0P30017), equipped with an impact energy limiter (parachute), as is required by the urban flight legislation.

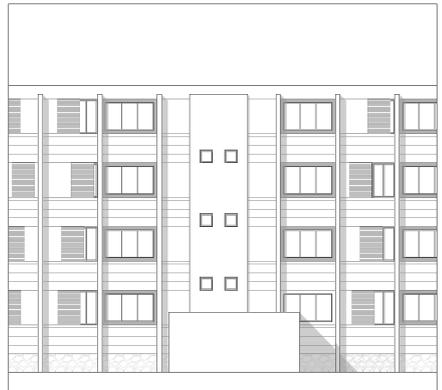
ALZADO (E) ESTADO DE PREVIO

Figure 10. Example of the planimetric survey made of the previous and the current status. Pathologies and modifications are shown. Linear building

project status, end-of-built status, current status and improvement modification status. The building pathology and historical modifications observed during the survey will be identified (Fig. 10). This allows to determine a case study graphic constructive evolution, from its beginning to nowadays. Therefore, a new refurbishment and improvement stage could be proposed.
