## CONSERVATION MODEL FOR BASILICA OF SMYRNA AS AN THEORETICAL INTENTION

Tugba Saricaoglu

Department of Architectural Restoration, University of Dokuz Eylul, İzmir, 35290, Turkey. [tugbasaricaogluts@gmail.com](mailto:tugbasaricaogluts@gmail.com)

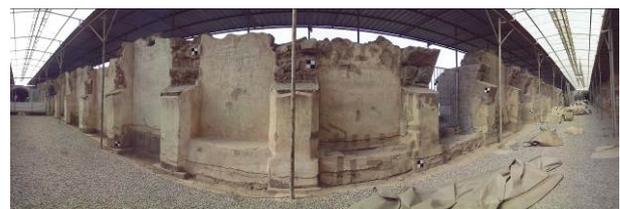
Figure 1: Graffiti on cryptoporticus wall.

Basilica of the Smyrna is the one of the most interesting Roman basilicas (Akurgal 2002), 2nd century BC, which has significant scale (161,4 meters to 29,3 meters) and also original graffiti (Taslialan and Drew-Bear 2004) (Fig. 1) on its cryptoporticus walls (Fig. 2). The ultimate purpose of this research is integrating Basilica of Agora in Smyrna into today by analysing its cultural, historical and physical situation using digital methods to survey it. Even this integration will be theoretical it will be a method and survey model for the future studies which will be not just theoretic but also practicable hopefully.

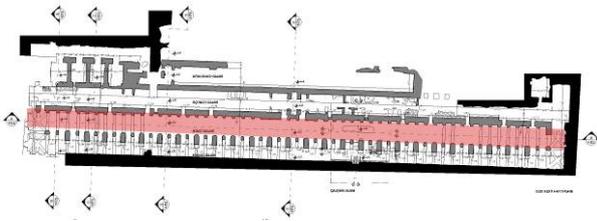
Figure 2: Cryptoporticus wall (second gallery).

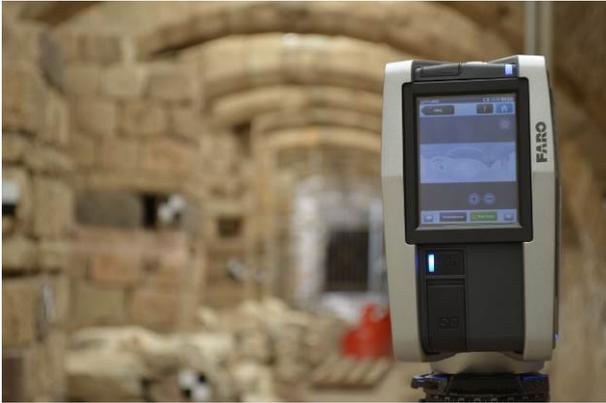
Figure 3: Faro Focus 3D S 120.

Documentation of the building made by using terrestrial laser scanner (Saricaoglu 2015) (TLC)-Faro Focus 3D S

120) (Fig. 3). The pointcloud of the building scanned up to 200 scans and two different scan durations- 9 minutes and 16 minutes, and took ten days. These time differences were decided accordingly detail of the elements of the ruins. In other words, cryptoporticus walls which has graffiti remnant was scanned for 16 minutes, the other part of the basilica scanned in 9 minutes per scan for 200 scans. Pointcloud data (Figs. 4 and 5) developed and used to generate orthopoint data (Fig. 6). Subsequently, CAD based drawings of the building made from generated data.

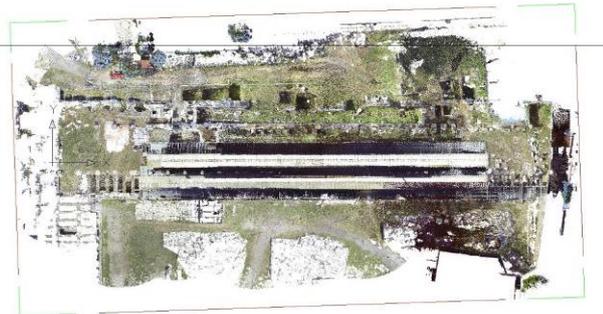
Figure 4: Pointcloud data of the basilica and its near surroundings.

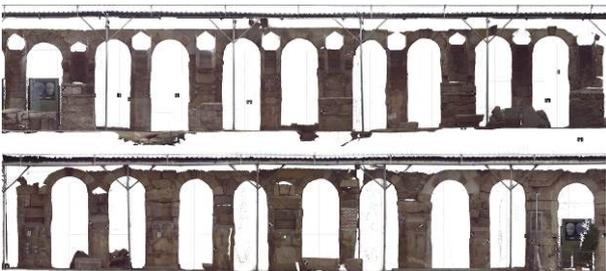
Figure 6: Orthophoto samples of the basilica.

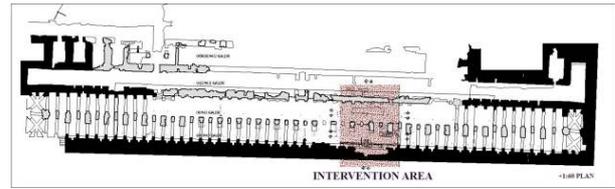
Figure 7: Intervention area.

Conservation problems evaluated after documentation of the building exclusively. The model intervention area (Fig. 7) is decided according to those conservative issues which are conservative problems, structural problems, and awareness problems of the building.

In conclusion, after identifying basilica's conservative issues under the names of, structural, and awareness, modeling sample intervention intersection (Figs. 7 and 19) is generated by using those outcomes. Accordingly, sample intervention area is decided to be at the southeast of the basilica and limited with 33th and 38th axes involving the first and the second galleries (Fig. 20). The 35th and 36th of these axes have been chosen as an application area, in order to make two different sampling and proving modulation for the future, as presented in Figure 21 and Figure 22.

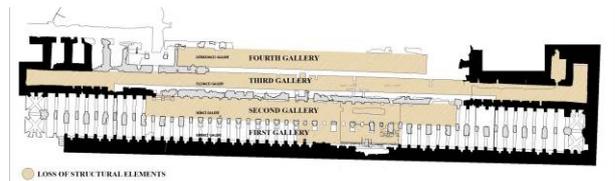
Figure 8: Deprivation of structural elements.

Basilica was built in stone masonry technique (also techniques of belt, vault, cross vault etc. masonry, gap passing) matching with its periods (Hellenistic, Roman). The main problem when basilica's material and spatial qualifications evaluated within this scope is that there are material deprivation especially in the bearing elements in consequence of building's being under earth and its being urgently repaired because of the earthquake (Bean 2001), A.D. 178, it earlier on faced with. Although these deprivations are not in a very systematical construct, they are in high level that can affect the holistic stability of the building in long term, as presented in Figure 8.

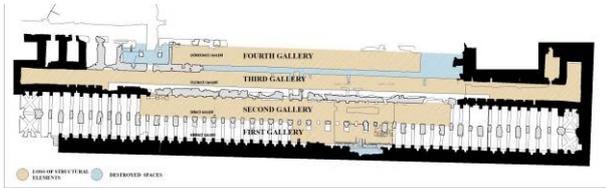
Figure 9: Loss of structural elements and destroyed spaces.

Another one of the material deprivation of the basilica is the demolished area other than belts. These areas are comprised of walls dividing the galleries and terrace walls, ruins in the area with ladder where a modern metal-made systematic gate was constructed, as presented in Figure 9.

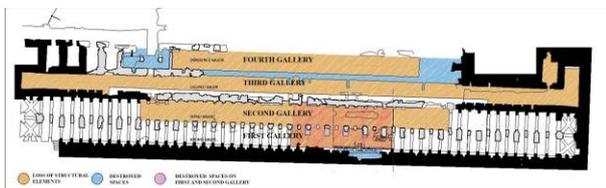
Figure 10: Loss of structural elements on first and second gallery.

When the structural material deprivation examined systematically, the deprivation of the same bearer axes detected in the first and second gallery, as presented in Figure 10. In addition to this finding, the area where all the material deprivations overlap, most damaged area (Fig. 11), is decided to considerable as one of the intervention model data parameters.

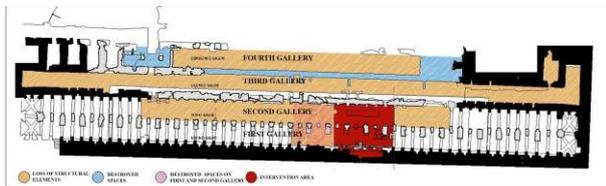
Figure 11: Most structurally damaged area.

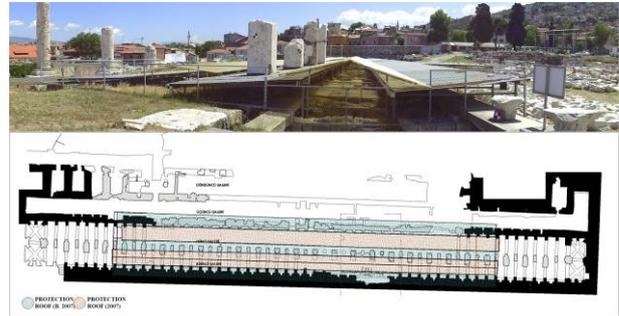
Figure 12: Protection roofs of the basilica.

Since, basilica's tree-dimensional aspect is not spatially and socially perceptible former interventions that are three-dimensionally made are decrypted. Notwithstanding, those interventions are made in an urgent manner such as, "save the day" kind of context, they are physically sensible and radical. The one of the interventions are protection roofs (Figs. 12 and 13). The first roof, which covers abutments of the basilica's first and second galleries, made before 2007 after excavation (Ersoy 2010). The second roof is the one built for the covering of the bare places of the ruins in 2007 (Ersoy 2010).

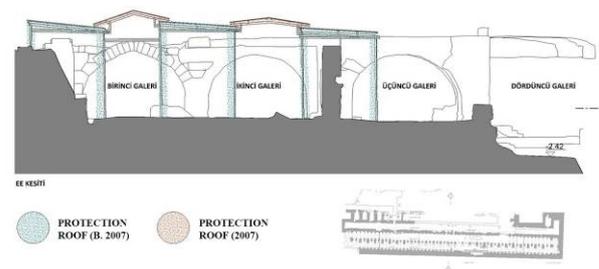
Figure 13: Protection roof sof the basilica, section.

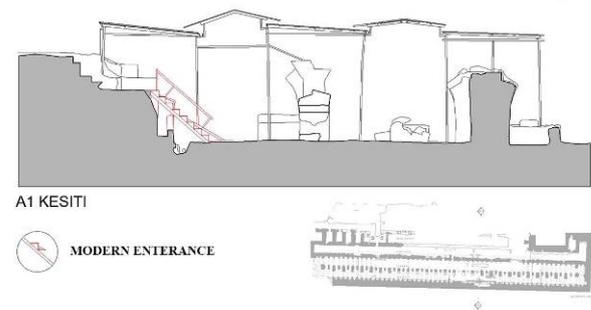
Figure 15: Modern entrance of the basilica, section.

the southeast of basilica provides direct entrance to inside (galleries) (Fig. 15). However, as this entrance is demolished during excavation (Ersoy 2010), it was fixed with temporary expedients and only exists for the usage of academic and professional employees.

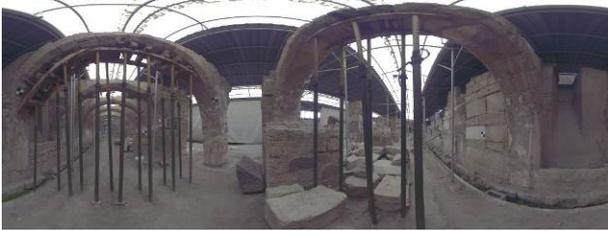
Figure 16: Metal stands to strenght abutments.

The other intervention is the metal stands which supports belts and abutments (Fig. 16). These strengthenings were made urgently and actually prove basilica's being under a systematic physical threat. One of the other reinforcement is recontraction of eight belts, with little belts in between, are placed in the first gallery (Fig. 17).

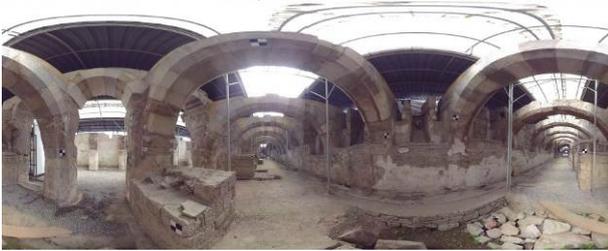
Figure 17: Restorated belts.

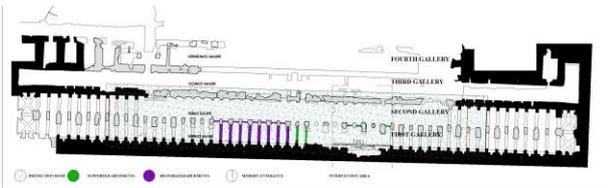
Figure 18: Conservative interventions on site.

Since all these interventions have been made for avoiding structural thaw, they underline the one of the main conservative issues, awareness, as a result of structural problems of the building. All in all, all of the interventions mentioned before creates specific area

when overlap (Fig. 18), that spatial intersection will be considered second of the intervention model data parameters.

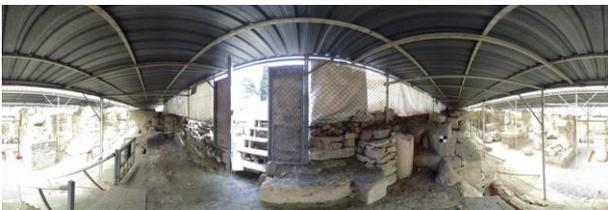
Figure 19: Intervention area, image.

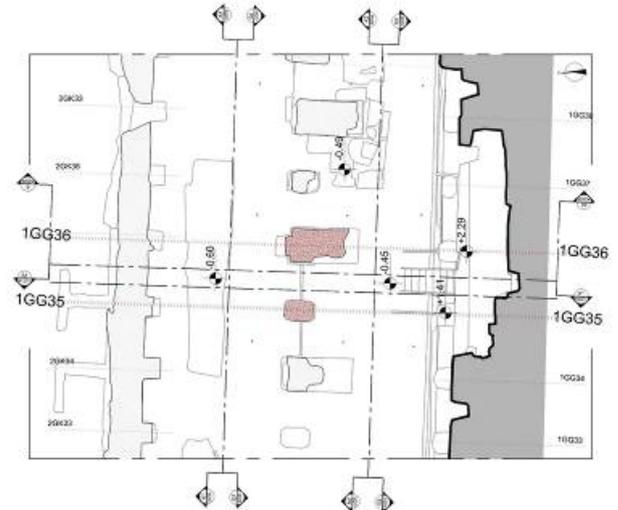
Figure 20: Intervention area, plan.

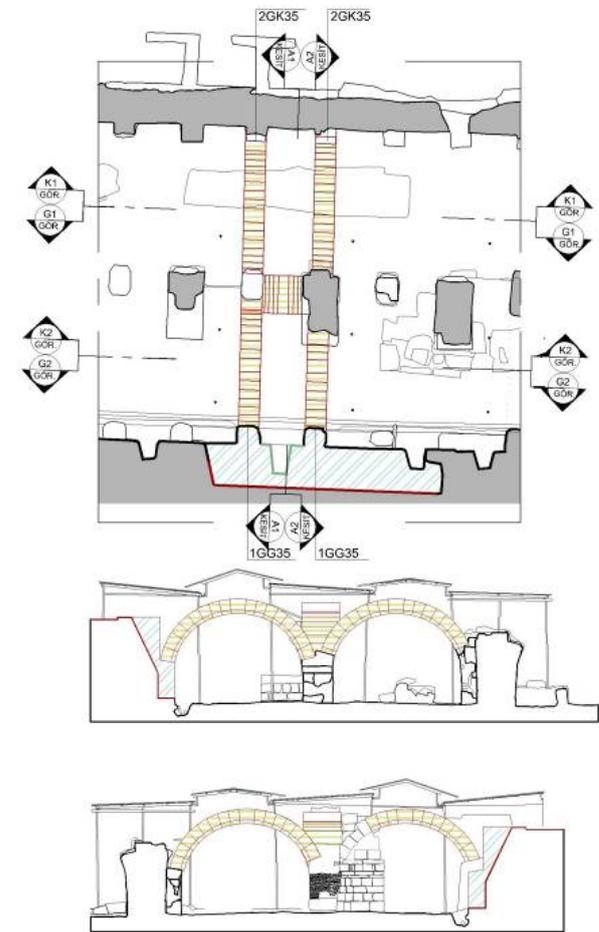
Figure 21: Intervention area, drawing, intervention mapping.

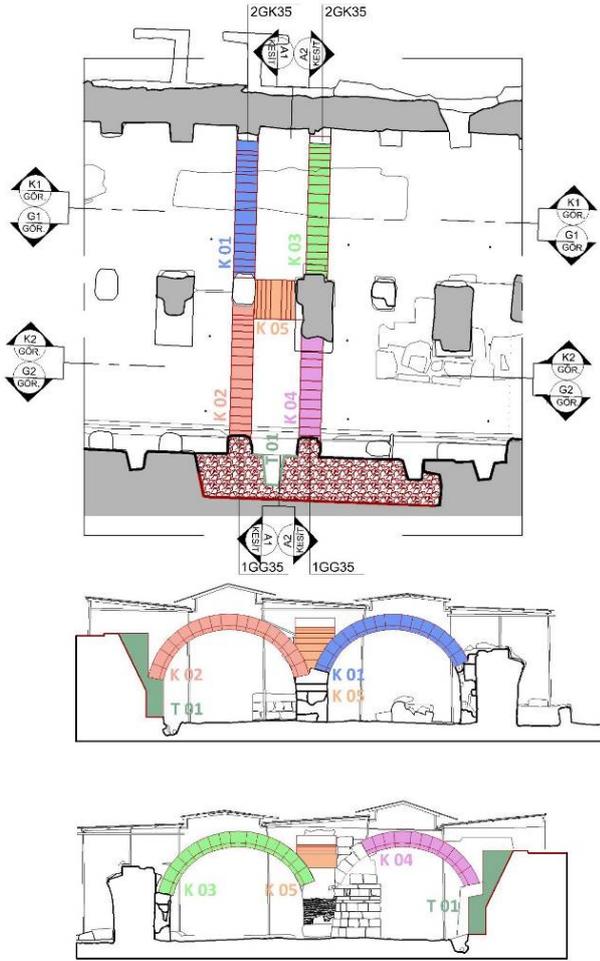
Figure 22: Intervention area, drawing, detailed mapping.
