San Fernando Batteries in Portobelo - Panama: building materials characterization and the environmental impact evaluation

Specifically this paper shows preliminary results obtained by mineralogical and petrographic characterization carried out by Polarized Light Microscopy (PLM), Environmental Scanning Electron Microscopy (ESEM-EDX) and X-Ray Diffraction (XRD) investigations.

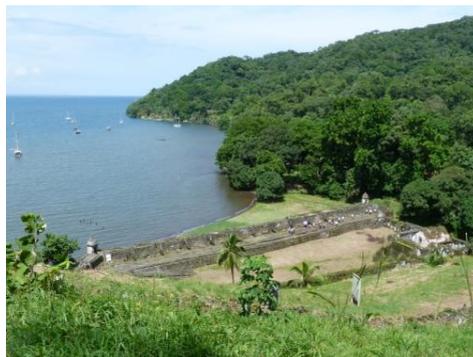
Fig. 1- Overview of the Lower Battery. The proximity of the sea is clearly visible.

It has to be taken into account also the tidal variations, which affect the Lower Battery, being in proximity of the sea (Fig.1); indeed, even the inner part of the Fort is subjected to the water permeation.
