## The construction materials and static-structural aspects of the Budello tower (Teulada, southwest Sardinia, Italy)

Stefano Columbu<sup>a</sup>, Gian Matteo F. Picchizzolu<sup>b</sup>, Antonio Cazzani<sup>c</sup>

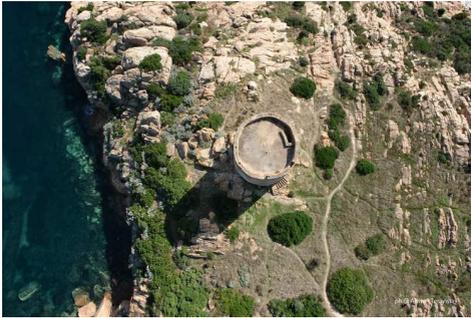
Fig. 1. Aerial view of Budello tower.

The Budello tower (Fig. 1), which is part of the larger Spanish defensive system in Sardinia, is a defensive post built in 1601 by the entrepreneur from Cagliari, Pietro Porta, already owner of the Piscinnì *tonnara* (the tuna catching plant). It is built in the municipality of Teulada Cagliari (38° 55' 55.57" N, 8° 43' 22.15" E) and in particular,

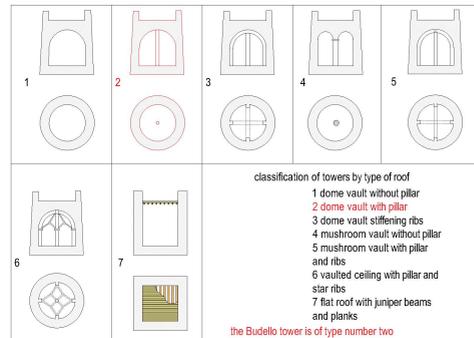
Fig. 2. Tower construction models; the Budello tower model is two type.

the entire Sardinian coastal defence system (Mele, 2000). The coastal defensive system consisted of three models of towers (Montaldo, 1992) (Fig. 2):

- *Gagliarde*, it was structured for a heavy defence, equipped with four large-caliber cannons;
- *Senzillas*, of medium size for light defence, it had two medium-caliber cannons, a pusher and three caliber rifles, two pusher and five rifles;
- *Torrezillas*, outposts of sighting and it had two rifles and a pusher.

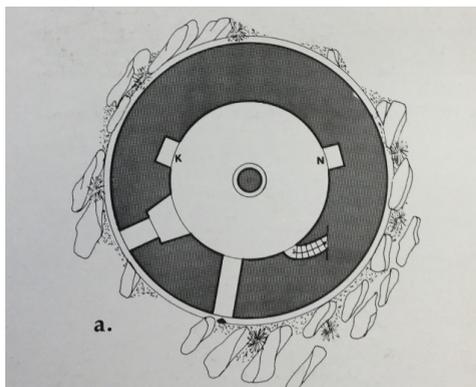
Fig. 3. Plan of the Budello Tower.

The tower has a circular section and a vaulted roof supported by a central pillar (Figs. 3 and 4). Along the internal perimeter there is the stairs for access to the roof terrace. Inside there is a room with a fireplace, a skylight and two slits.

The masonry wall in granitoid material found *in situ* is irregularly, it is composed of a mix of lime and small stones. Internal staircase is inserted inside the perimeter load-bearing masonry as in the plan (Fig. 3) and the axonometric representation (Fig. 4). The stairwell (Figs. 5 and 6) inserted inside the masonry, has the vault made up by a juniper wood deck, typical of local ar-boreal essence.

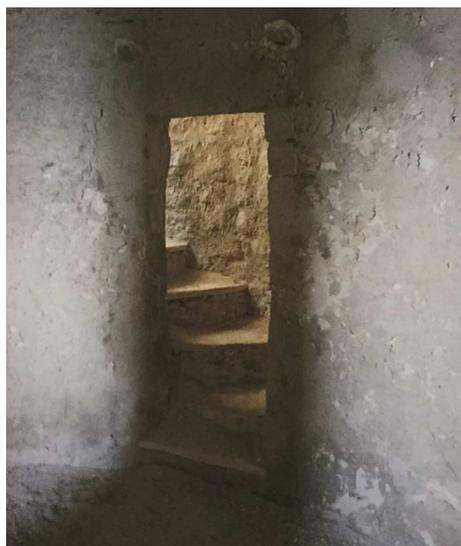
Fig. 6. The staircase of Budello tower.

The research aims to study the architectural morphological aspects, belongs to the *senzillas* category, characterized by a central column in stone material (that supports the vault surmounted by the roof), a staircase grafted into the revolving perimeter (Fig. 6), a conical wall structure.

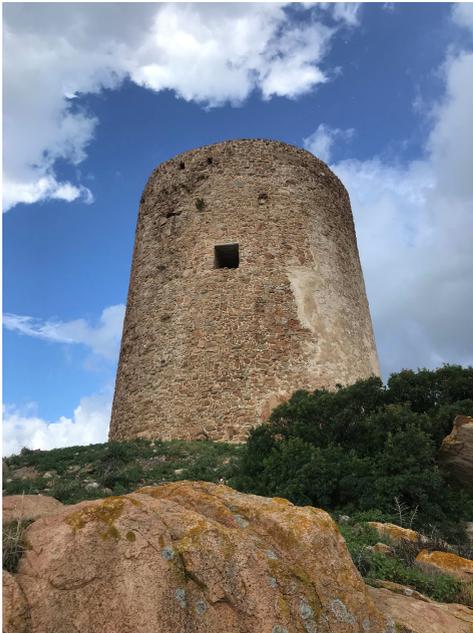
Fig. 7. Budello tower from south-east view.

The tower, located on a rocky promontory weakly emerging with respect to the surrounding territory (Fig. 7), it was mainly built with ashlars (Fig. 8) consisting of local granitoid rocks (about 90%) belonging to the plutonic complex of the Carboniferous Superior - Permiano, represented in the area near the tower by equigranular leucogranites and equigranular granodiorites. Occasionally we find the presence of other magmatic rocks belonging to the dikes associated with the plutonic complex outcropping in the area, and sedimentary rocks (sandstones, calcarenites).

The stone ashlars of the truncated-conical structure rest directly on outcropping granitoid rock (even if rather irregular), not on a horizontal plane, but in an irregular way following the natural morphological variations of the rocky outcrop (Fig. 7); there are apparently no foundation structures, which otherwise would not have been necessary. The ashlars of the main wall structure are irregularly shaped (Fig. 8), slightly rough-hewn in stakes (bundle), with dimensions that vary on average from a minimum of 10 cm to a maximum of 50 cm (Figs. 4-8 ), with a greater frequency between 20 and 30 cm (Figs. 7, 8). Near the openings (jambs, architraves, etc.) the stone elements are squared at least on two sides (sometimes on 3 sides). Both in the wall structure and in the decorative elements are present stone ashlars of re-use in more recent times, and above all of replacement and integration of rocks in the renovation and restoration of the last ones the decades.

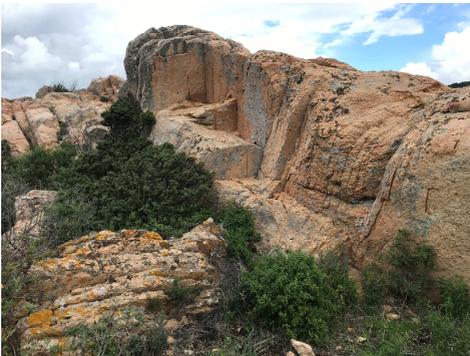
Fig. 9. Quarry granitoid outcrops from which the ashlars used for the tower were extracted.

The granitoid rocks used in the tower masonry were quarried in the area in front of the building (Fig. 9). In fact, in the area surrounding the tower there is the presence of small intrusive rock plateaus, presumably referable to the original quarry planes. These are observed both west and

north of the tower. In these two sectors, especially in the northern one, today it is still possible to see the traces of working for the extraction of the stone blocks or ashlars, represented by chipping holes generated by the chisels. The extraction method was very simple, because it exploited the natural conformation of the outcropping rock: the stone ashlars were derived using the cracking / fracturing present in the rock outcrop, characterized by two sub-orthogonal fissuring orientations.

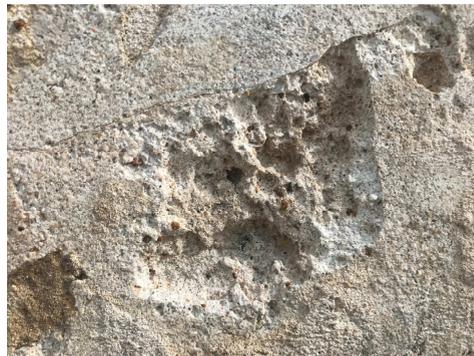
Fig. 10. Plaster mortar from west side of tower wall.

The original plaster mortars are present only in the north side of the tower, while in the other sides they are absent and partly replaced by the mortars of periods following the first installation of the tower. From a compositional point of view, there is a similarity with the render mortar and bedding mortars even if we observe a lower grain size of the aggregate used, as indeed good construction technology requires. It is not to be excluded that even this aggregate was taken from the finest fraction of the sand of the beach near the tower.
